# Hydrological and planting design of an experimental raingarden at the Royal Botanic Garden Edinburgh

David A. Kelly<sup>1</sup>, Kirsty Wilson<sup>2</sup>, Aravindan Kalaichelvam<sup>3</sup> & David Knott<sup>4</sup>

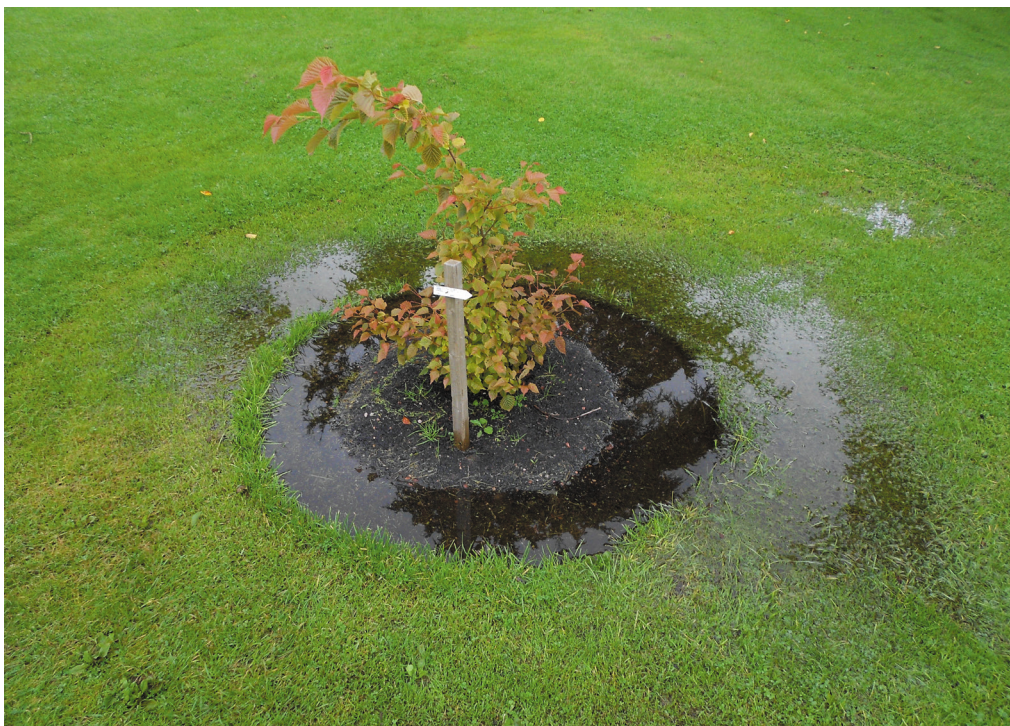
**Fig. 3** Shrub roots submerged following heavy rain in February 2017. Photo: David Knott, RBGE.

The impact of heavy rainfall events has caused a number of problems across the Garden, including waterlogging and localised flooding. These problems have caused damage to plant beds, lawns and footpaths, and has impacted staff and visitor access due to the closure of affected areas. Figs 2–4 show instances when heavy rain has caused waterlogging of lawns and the submersion of tree and shrub roots – with potential consequences for plant health. Waterlogging of lawns has also affected garden maintenance, making grass cutting difficult and causing soil compaction.

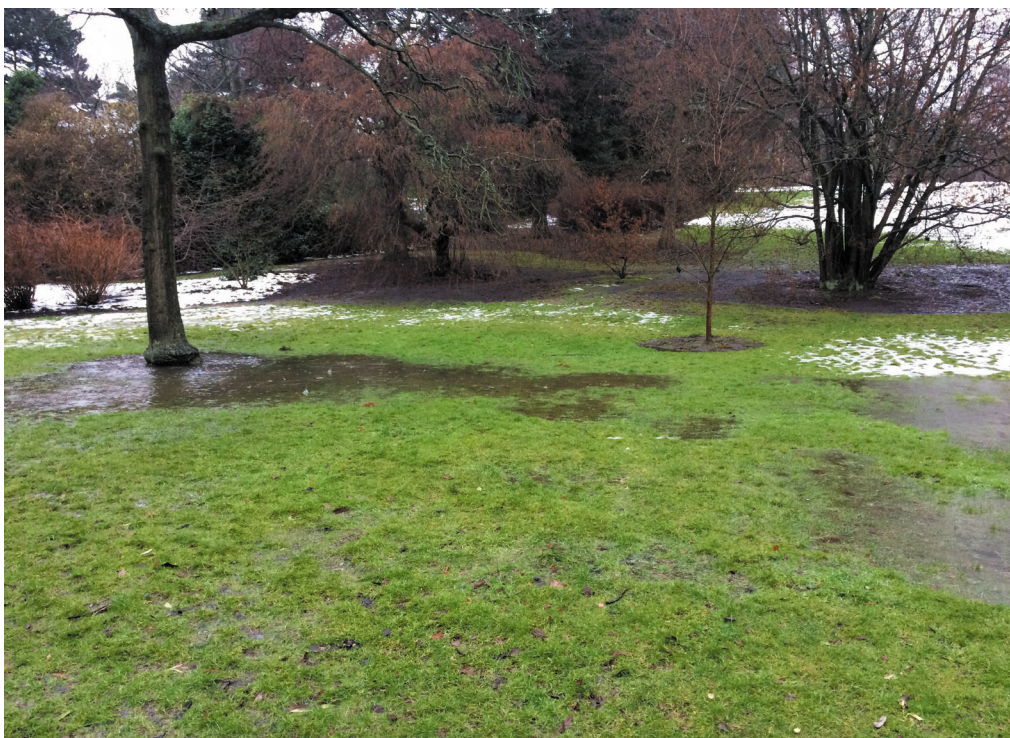
**Fig. 4** Waterlogging and root submersion following heavy rain and snow in May 2018. Photo: Leonie Alexander, RBGE.

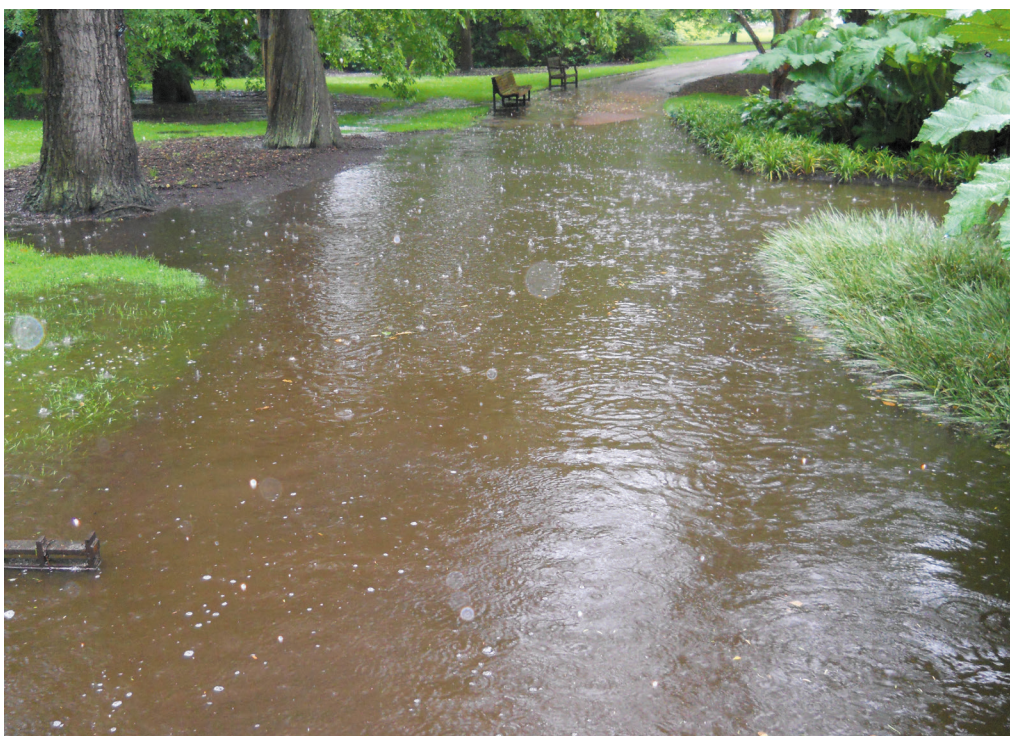
**Fig. 5** A section of a main footpath flooded following heavy rain in July 2017. Photo: John Mitchell, RBGE.

The impact of more extreme rainfall events can be seen in Figs 5 and 6; extensive localised flooding occurred in July 2012 (the second-wettest month on record), submerging and blocking a main footpath. After such events, remedial work has been necessary to repair the footpaths and plant beds where soil and surface materials have been washed away.

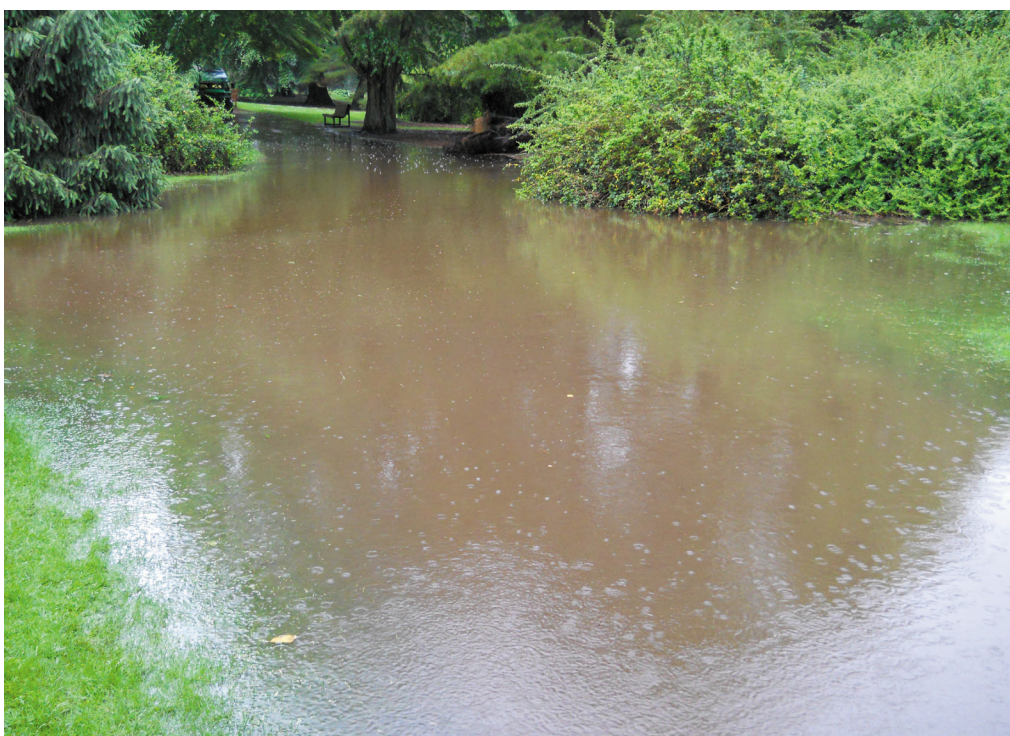
**Fig. 6** Further flooding of a main footpath following heavy rain in July 2017. Photo: John Mitchell, RBGE.

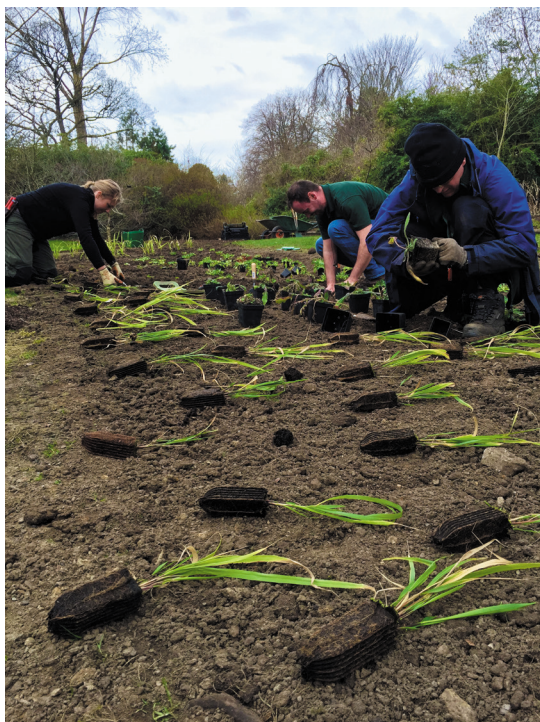
**Fig. 14** Members of the horticulture team lay out the young plants before planting into the amended soil of the raingarden. Photo: David Kelly, Heriot-Watt University.

Planting of the raingarden took place in March 2019. Fig. 14 shows this in progress with members of the horticulture team having laid out the young plants ready for planting. Once complete, a layer of gravel was spread over the bioretention area of the raingarden and organic mulch was added to the surrounding area. These gravel and mulch layers were used to help retain soil moisture during dry periods, whilst also helping to protect the amended soil from erosion, aid plant establishment and reduce maintenance by suppressing weeds.

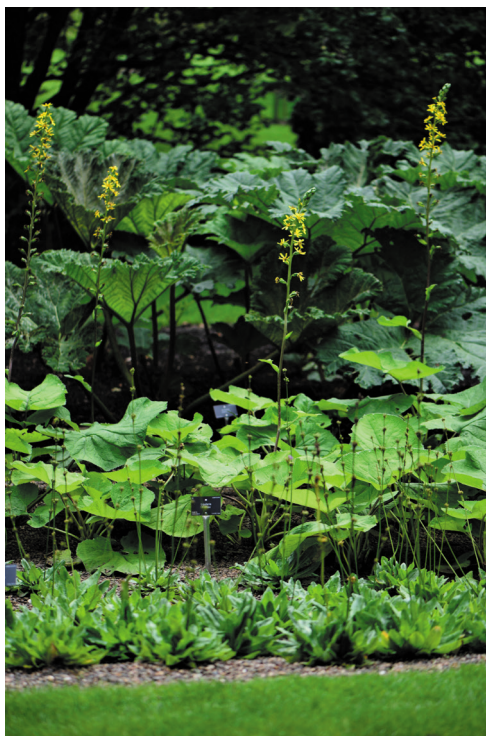
**Fig. 16** A close-up view of the raingarden in summer 2019, showing the different layers of planting. Photo: Kirsty Wilson, RBGE.

The plants developed well in the months following planting. Fig. 15 shows the raingarden in the summer of 2019, with the planting having become well established. Fig. 16 was taken that same summer and shows the different layers of planting, ranging from those at the edge of the raingarden where soil conditions are drier, to those at the centre and far side where wetter conditions are expected. Figs 17 and 18 show the raingarden in spring 2020 after the mulch surrounding the raingarden had been renewed.

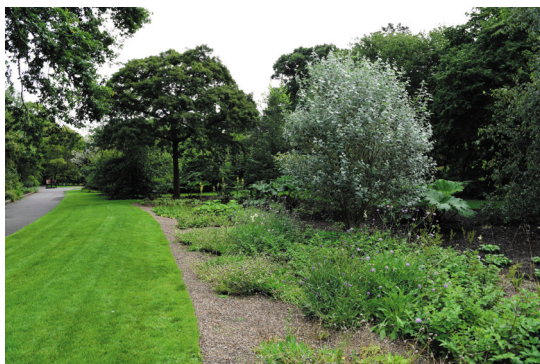
**Fig. 15** A view of the raingarden from its west side in summer 2019, showing the planting now well established. Photo: Kirsty Wilson, RBGE.

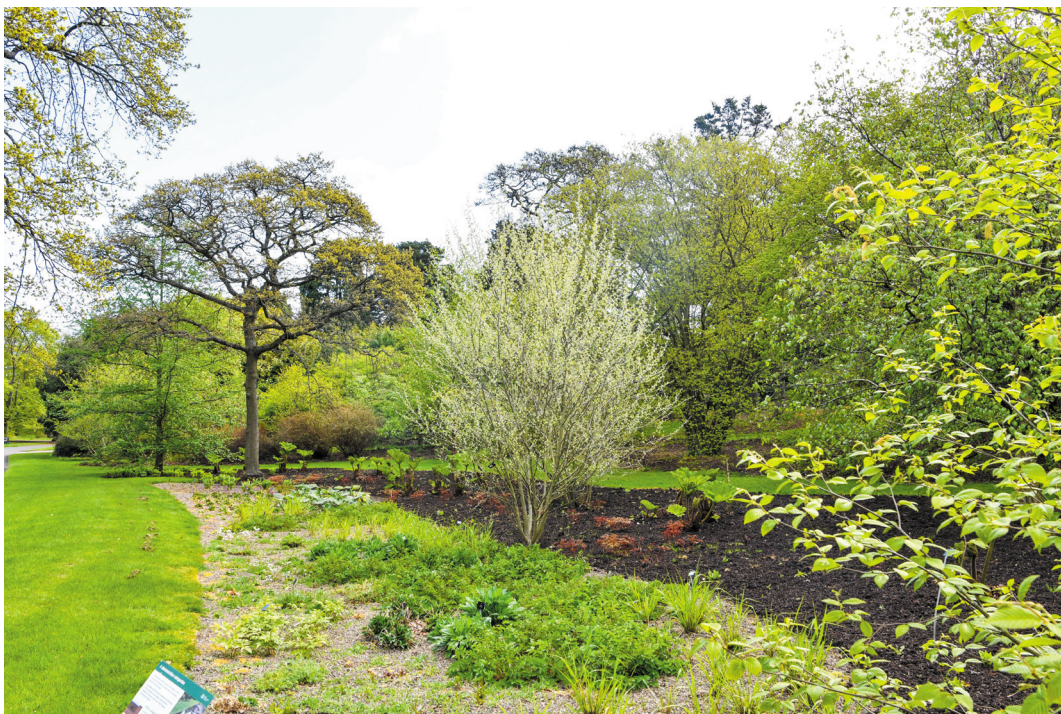
**Fig. 17** The raingarden in spring 2020 following the addition of new mulch to the surrounding area. Photo: Kirsty Wilson, RBGE.

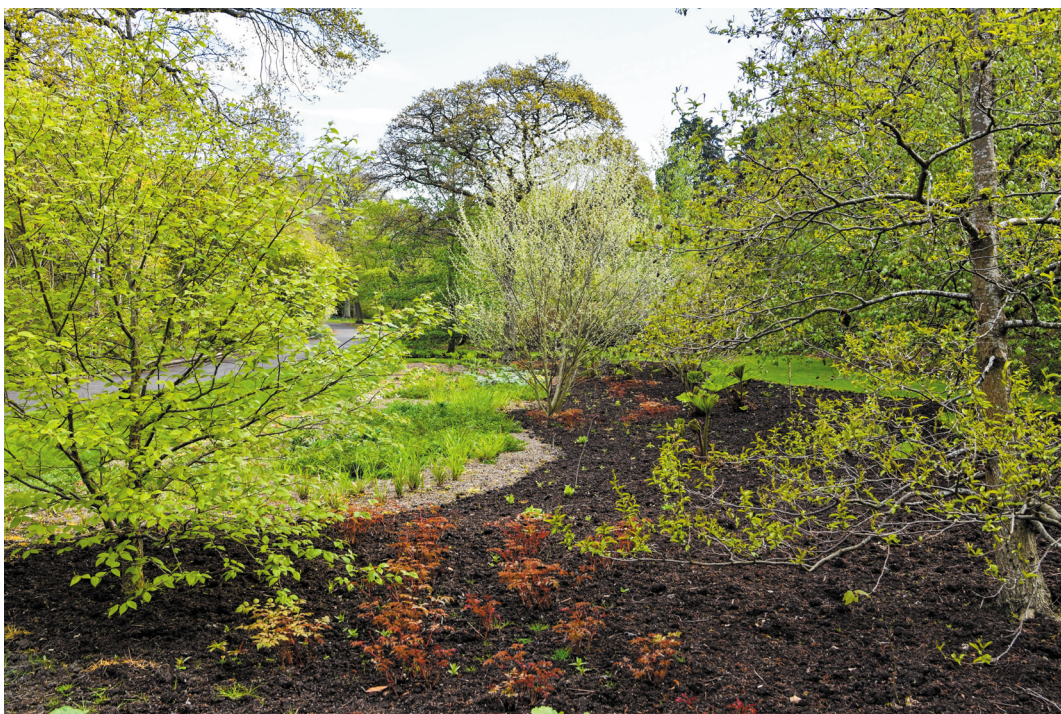
**Fig. 18** New mulch added to the area surrounding the raingarden, taken in spring 2020. Photo: Kirsty Wilson, RBGE.
